# Incident Report

<b>Date</b>	<b>11 June 23</b>
<b>Location</b>	Between Dunnottar Castle and Stonehaven
<b>Boat</b>	Spirit of Catterline
<b>Crew</b>	S1 (cox – 5.5 years experience. Medic. Female) S2 (stroke - novice. Female) S3 (#3 - novice. Female) S4 (#2 - novice. Female) S5 (bow. 10 years experience. Crew lead. Male)
<b>Conditions</b>	Mild. Some showers. Good visibility. Light breeze. Swell – moderate height, long period, somewhat confused.
<b>Summary</b>	<p>S3 was taken ill off Bowdun Head. Cramps in hand, jaw and chest, difficulty breathing, distressed and reduced consciousness.</p> <p>Mayday call was made and Shetland coastguard responded. Requested medical assistance and began making way back to Stonehaven.</p> <p>After a few minutes, waved down passing motor launch 'Fliss', and transferred S3 and S4 to Fliss. Fliss then took them to Stonehaven where they met the RNLI crew who were preparing to launch and handed S3 over to their care. Meanwhile, Spirit was rowed back to Stonehaven by S5 and S1, with S2 coxing.</p> <p>S3 received treatment and was subsequently discharged from the RNLI to the care of her friend.</p>

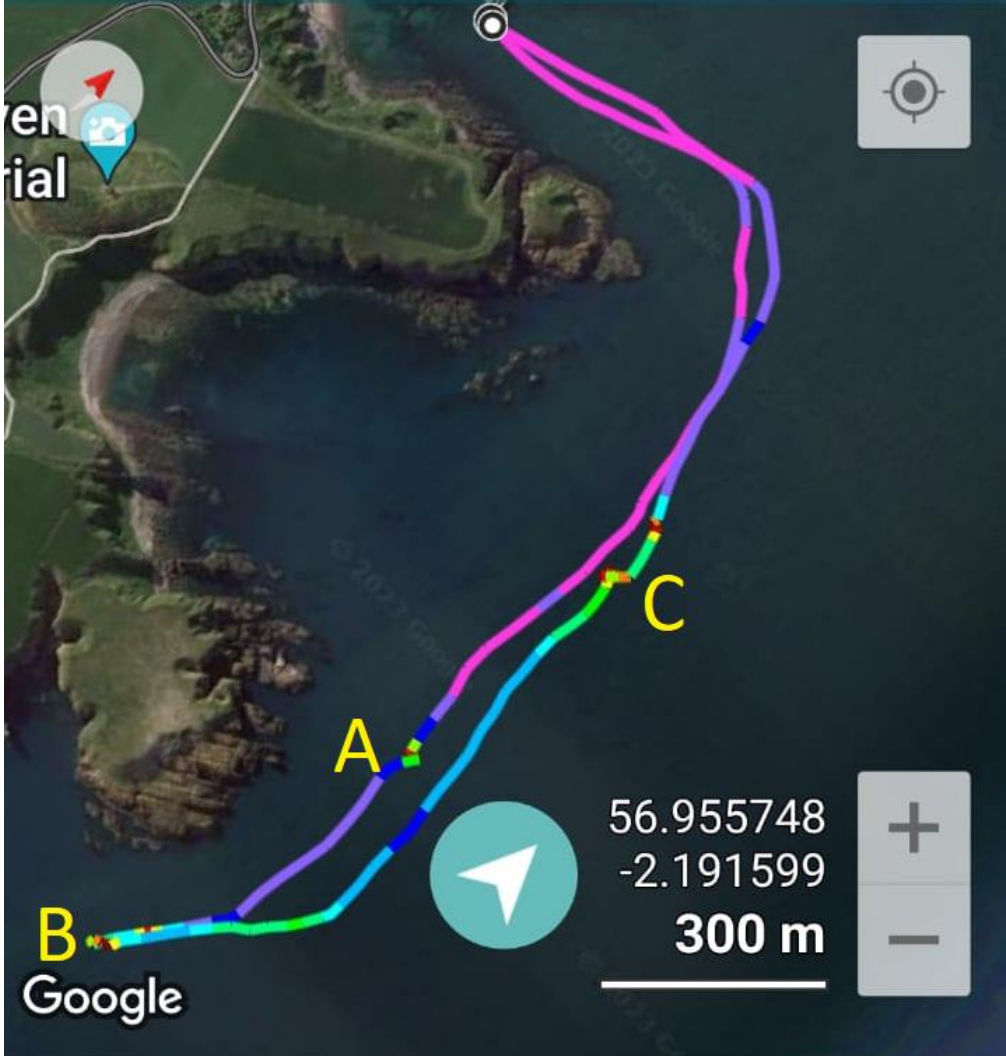
See map below for course and location markers.
